PUBLIC WORKS BUILDING and ANNEX

Building Location: 611 Walker Street Houston, Texas

Date of Site Visit: 9/20/06

**Field Notes, Background & General Observations**

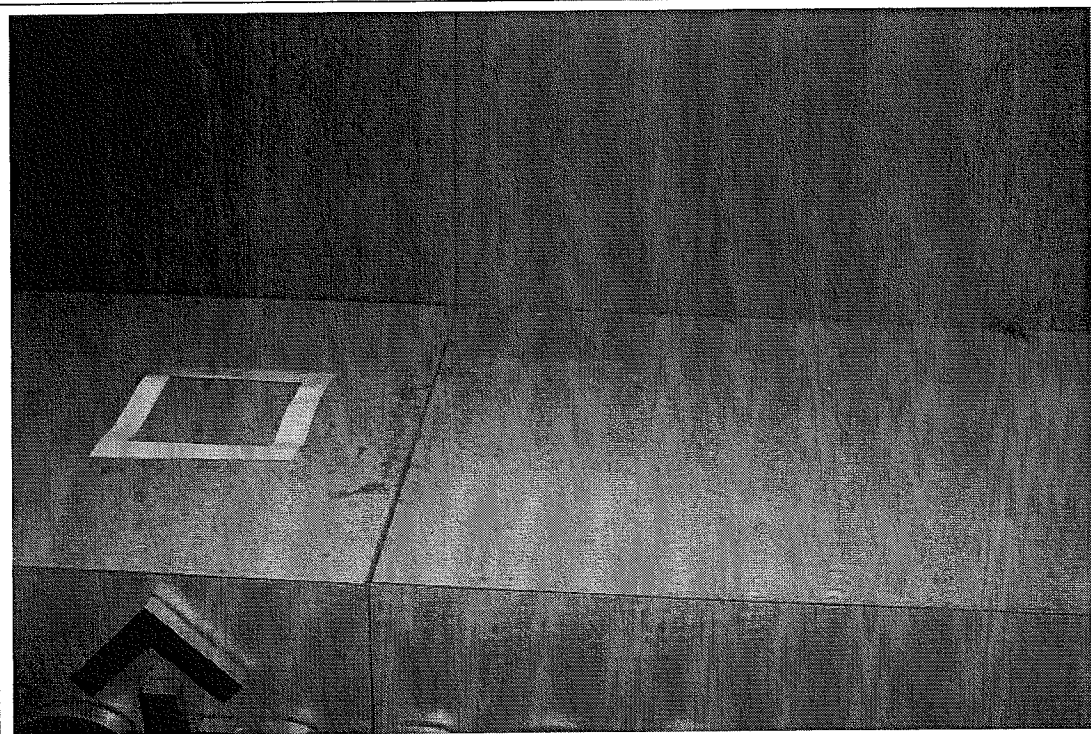
Photo 74. Basement - Location of dust sample #8 (top of display case beneath acoustical plaster ceiling)

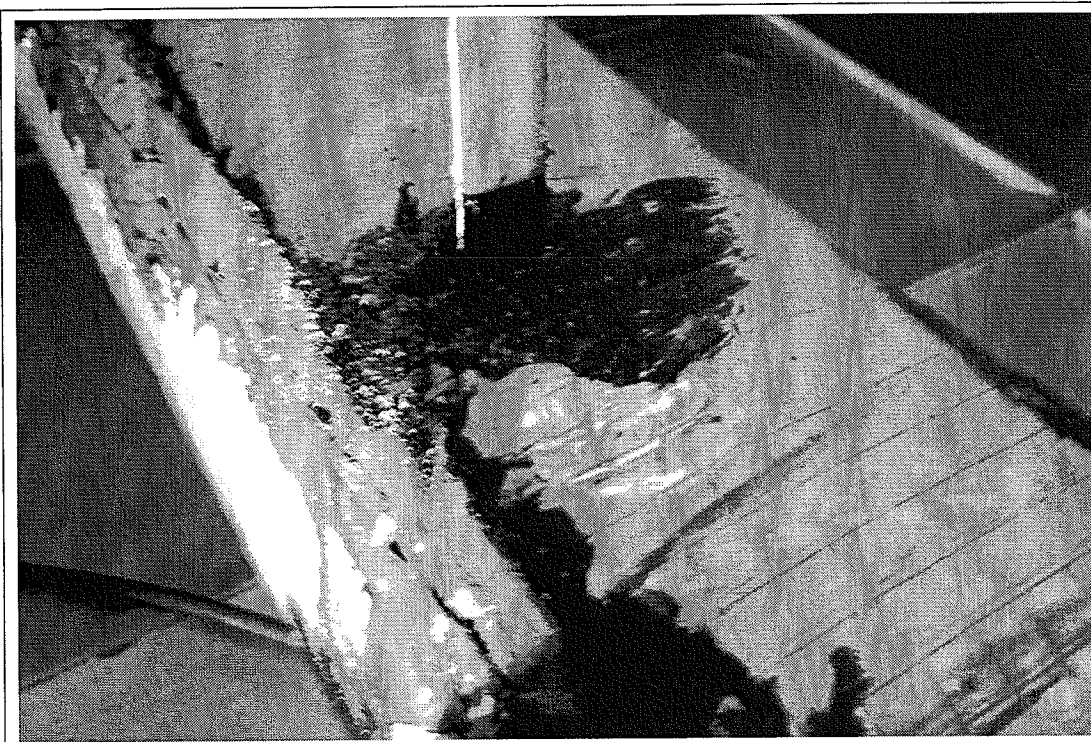
Photo 75. 10th floor, in W10111B - Location of dust sample #9 (top of foil wrapped HVAC duct in plenum above suspended ceiling)

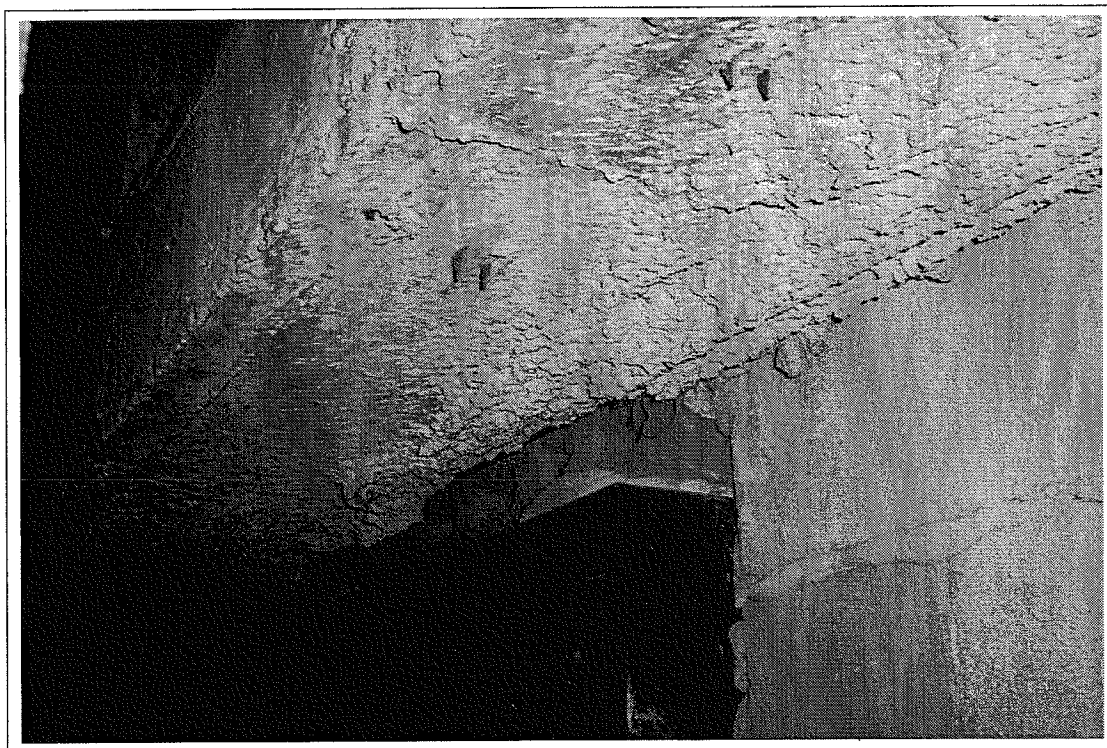
Photo 76. 20th floor, NE Fresh Air Shaft - View of damaged fireproofing on concrete structure (above dust sample location #1)
